12/19/2010 1
Inspection Date Visit. #

129 Mockingbird Ln.
Address To Be Inspected

East Wenatchee WA
City State

COMPLETE WOOD DESTROYING ORGANISM INSPECTION REPORT

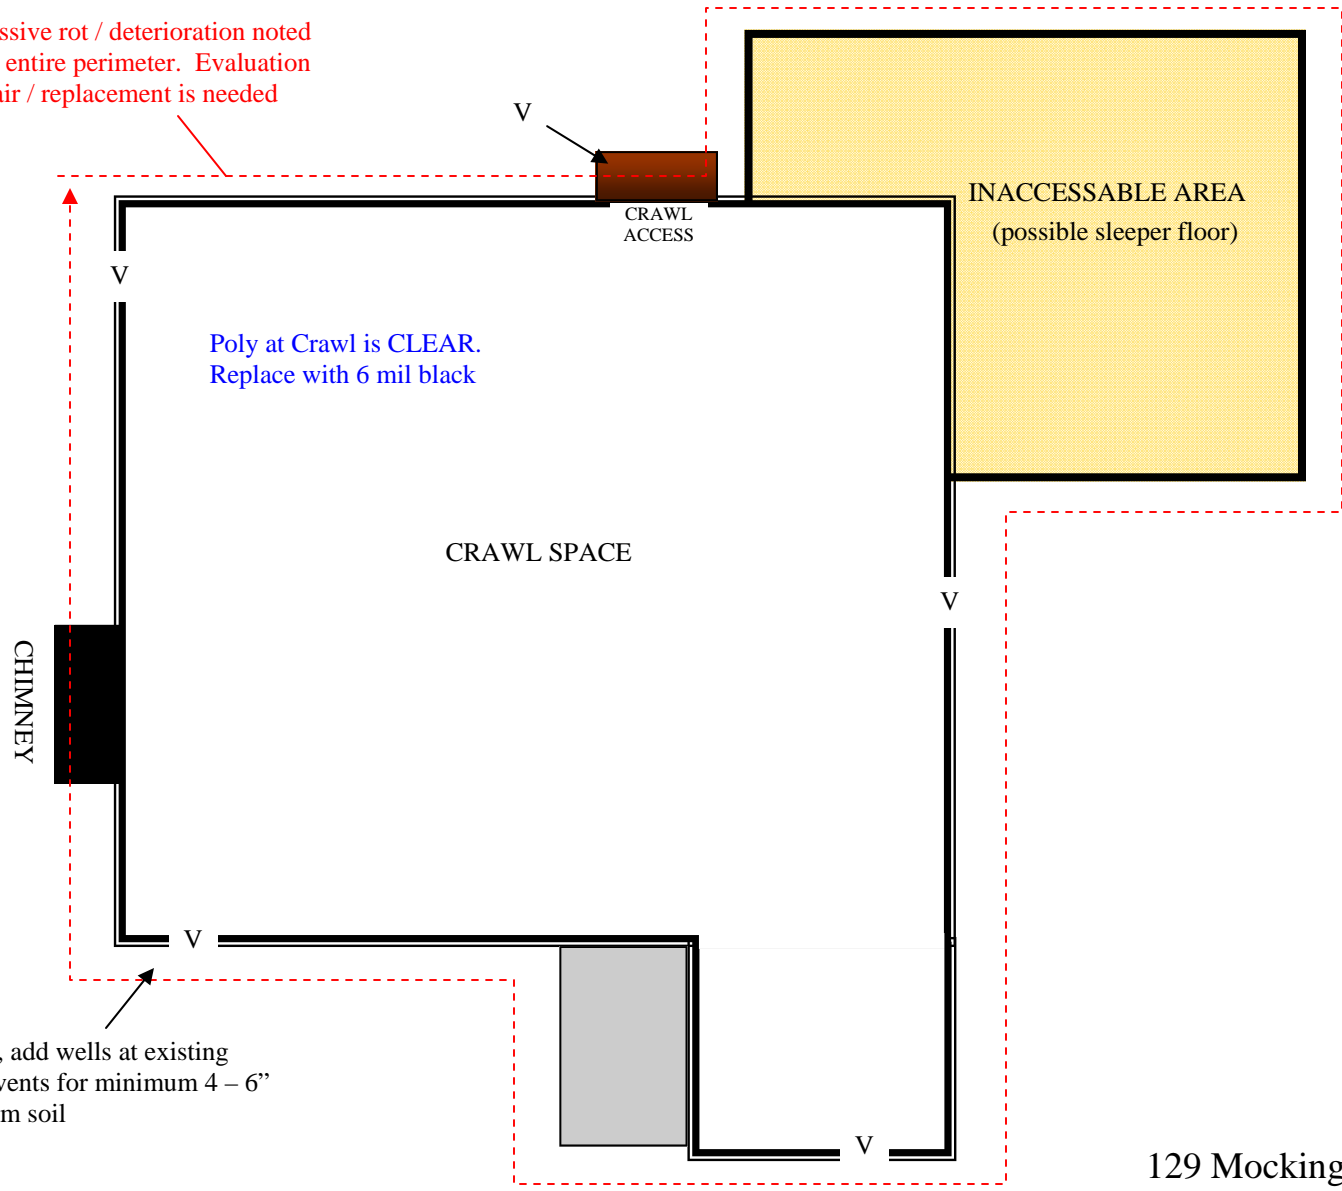
CONDITION: Moderate to excessive rot / deterioration at entire perimeter fascia and soffit. Further evaluation for extent of deterioration is needed.

CONDITION: Clear Poly at Crawl Space

CONDITION: Level of grade at Crawl Vents at perimeter and base of access at Crawl Entry

CONDITION: Inaccessible area under laundry / master bedroom, bathroom

Moderate to excessive rot / deterioration noted to soffit, fascia at entire perimeter. Evaluation for degree of repair / replacement is needed

Poly at Crawl is CLEAR.
Replace with 6 mil black

CRAWL SPACE

INACCESSIBLE AREA
(possible sleeper floor)

REMEDY: Remove damaged material as needed and replace. Verify extent of damage and effects on surrounding components not visible at time of inspection. Add ventilation to the soffit (minimum 2 vents per side)

REMEDY: Replace clear poly (remove) with 6 mil black per code.

REMEDY: Lower grade, add wells at perimeter vents to allow 4 – 6" of clearance from soil. Lower grade at crawl space entry at or below footing height. Update / re-enforce well of crawl access to limit current erosion of soil and moisture transmission to crawl space

REMEDY: Monitor - This area is assumed to be a SLEEPER FLOOR. Wood floor built over existing slab of converted garage. While this is a common application, construction details are NOT visible to inspection. No visual concerns were noted, no work orders assigned for this location (see drawing) Buyer should be aware of detail and monitor for any visible changes. Note, the area is a concealed space and does NOT have ventilation, typical to design.

Lower grade, add wells at existing
crawl space vents for minimum 4 – 6”
clearance from soil
