HOME INSPECTION REPORT

**167 Hilltop Sq.
East Wenatchee, WA**

PROFESSIONAL HOME INSPECTIONS

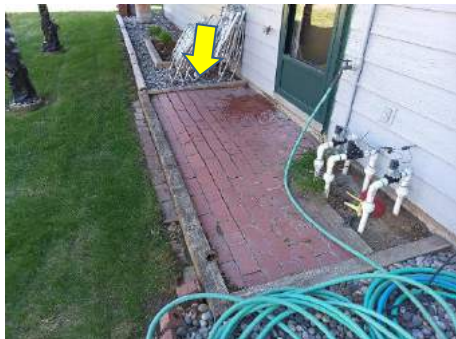
*Pavers at patio show degree's of settling. Monitor . - Driveway shows degree's of cracking. Monitor**

Brick paver patio shows degree's of settling Monitor

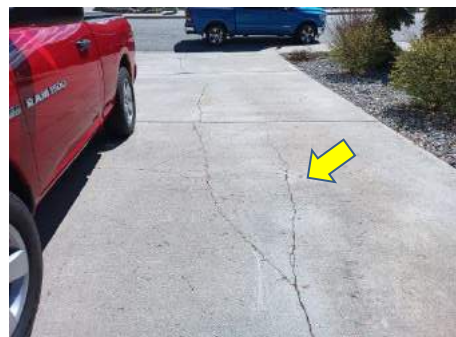
Example: Driveway shows degree's of cracking. Monitor*

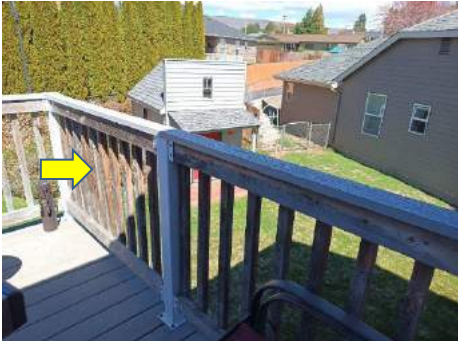
Finish at deck railings show heavy wear.

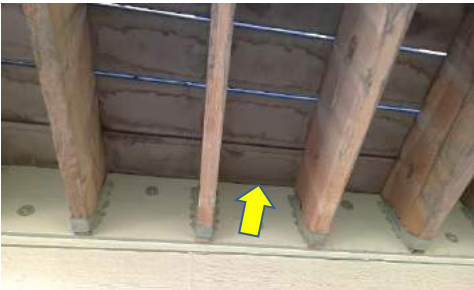
No deck to wall flashings, typical to age of construction. Education , monitor moisture impact at deck to wall transition.

No deck to wall flashings noted

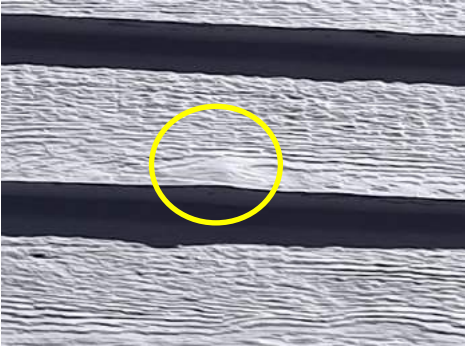
Signs of typical wear noted to drip edge of siding of style, vintage. Monitor*

Example: Signs of typical wear noted to drip edge of siding of style, vintage.

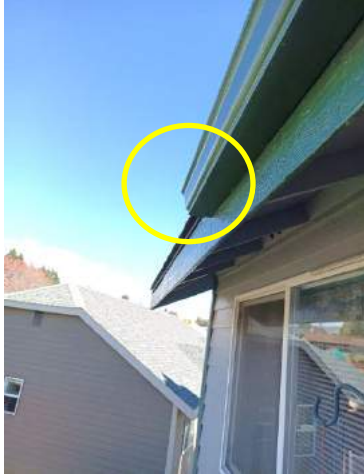
No down spout noted at rear gutter over deck.

No gutter noted at down spout off rear over deck. Education / review / update is recommended

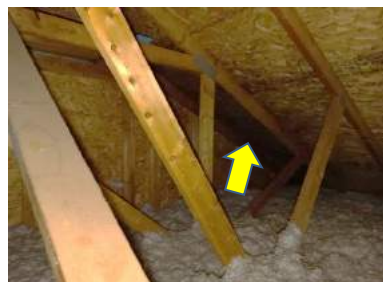
Example: Areas of minor mildew, moisture impact noted to sheeting .
Monitor*

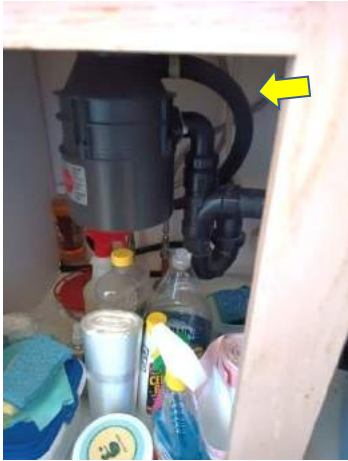
Improper routing of dishwasher drain line. Education /update to high loop is recommended

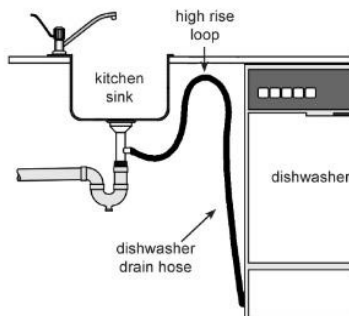
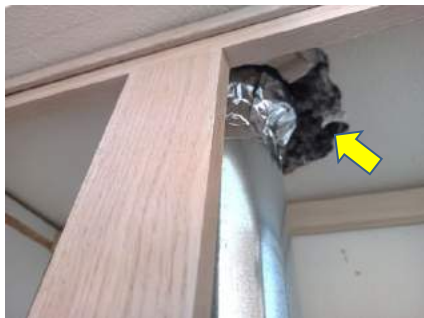
Seal oversized penetration for vent pipe at cabinet over range.

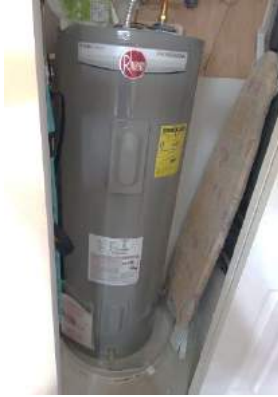
Hot water tank noted at laundry closet. Dated: 2019. No seismic straps noted at time of inspection

No seismic straps noted on hot water tank at time of inspection. Education / update is recommended

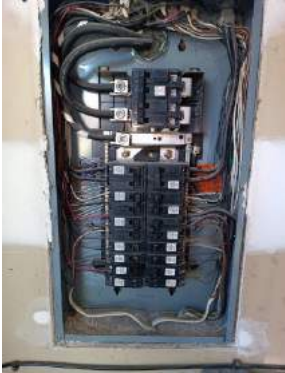
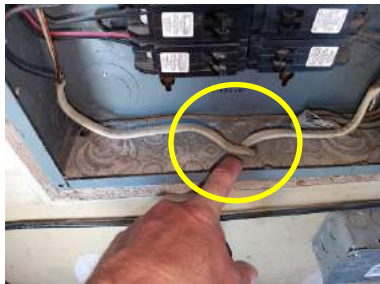
No compression collar / insulator on wire entering panel.

No compression collar, insulator noted at inlet wire to panel. Wire contacts panel. Education / update is recommended

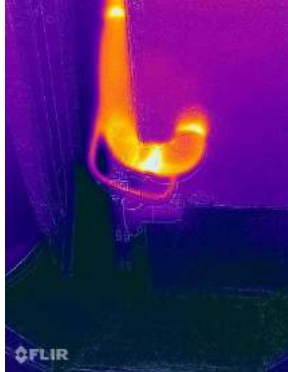
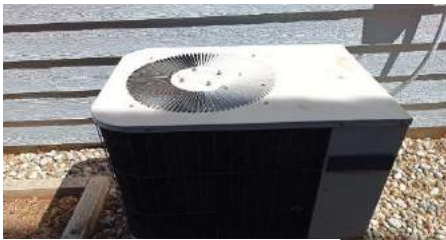
Exterior heat exchanger / AC Equipment is original and should be monitored due to age. Equipment was tested with thermal imaging.

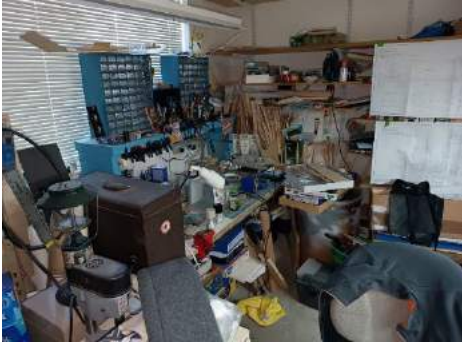
Some rooms had extensive storage / personal items, limited inspection was possible at these locations.

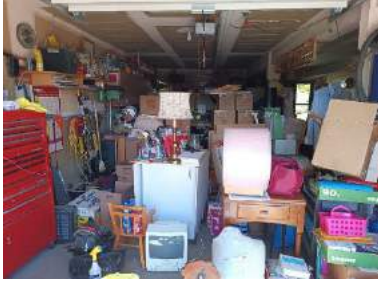
Inspection of interior of garage was limited due to extensive personal and storage items.
